Manhole Inspection Summary

Manhole # S35II_057MH

Location Address: **1618 BARCLAY ST**

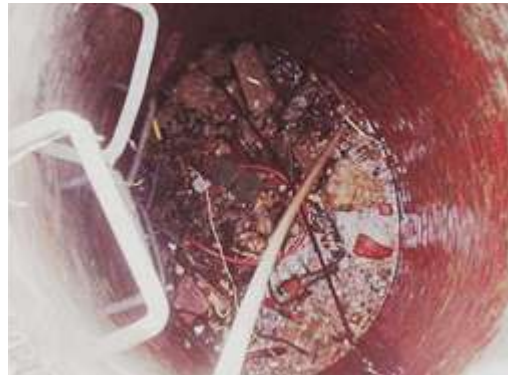
Top View

Channel debris.

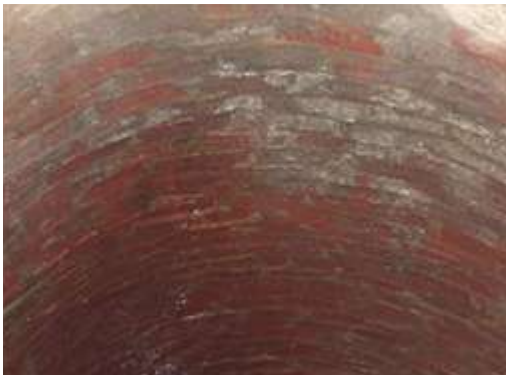
Defect

Infiltration: ☐ None ☒ **Joint** ☐ Cracks ☐ Mortar ☐ Roots ☒ **Wall**

Corbel and Barrel nfiltration.

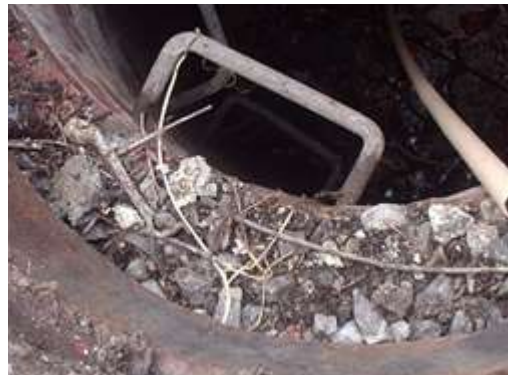
Defect

Frame Offset: **6** (in.) Condition: ☒ Sound ☐ Cracked ☐ Leaks

Frame offset.

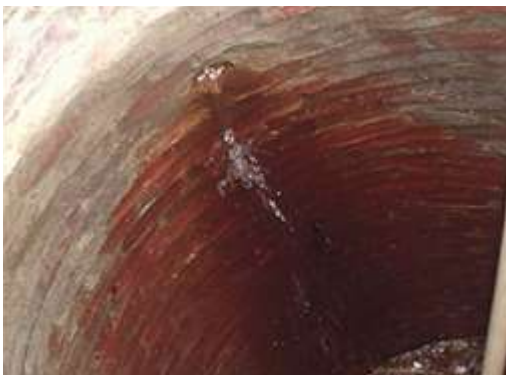
Defect

Comments **There is activce infiltration in the Corbel.**

Active infiltration in the Corbel.

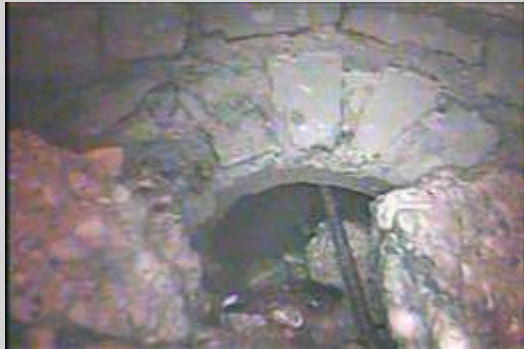
8 in. Circular Gravity Sewer
Pipe Out @ 12 O'Clock

Condition: ☐ Sound ☐ Cracked ☐ Root Intrusion ☐ Loose Brick ☒ **Deteriorated**

Infiltration: ☐ None ☐ Joint ☐ Cracks ☒ **Mortar** ☐ Roots ☒ **Wall**

Barrel deterioration and infiltration.
